APPENDIX D
RESTORATION PLAN STUDIES
& EXAMPLES

4.0 SITE PHOTOGRAPHS

Albany Pine Bush Landfill
 Albany, New York
Clough Harbour & Associates, LLP
 III Winners Circle, P.O. Box 5269
 Albany, New York 12205-0269

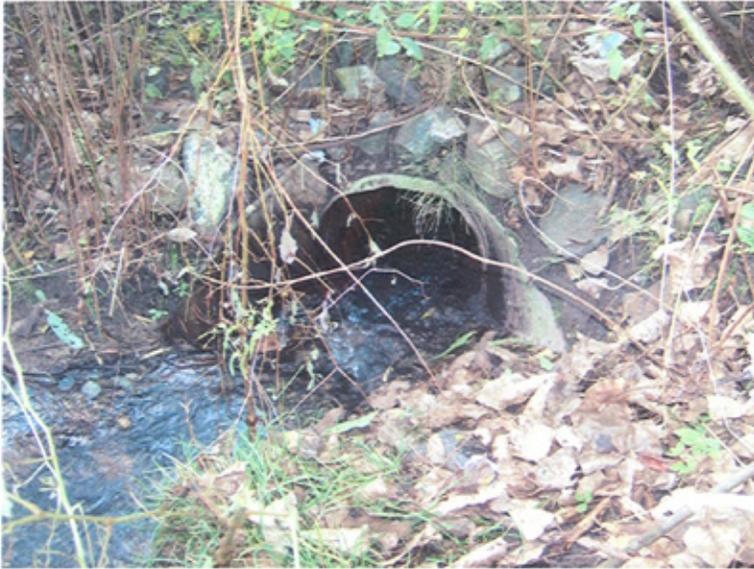
Culvert 1

2- 15" CMP pipes under Rapp Road

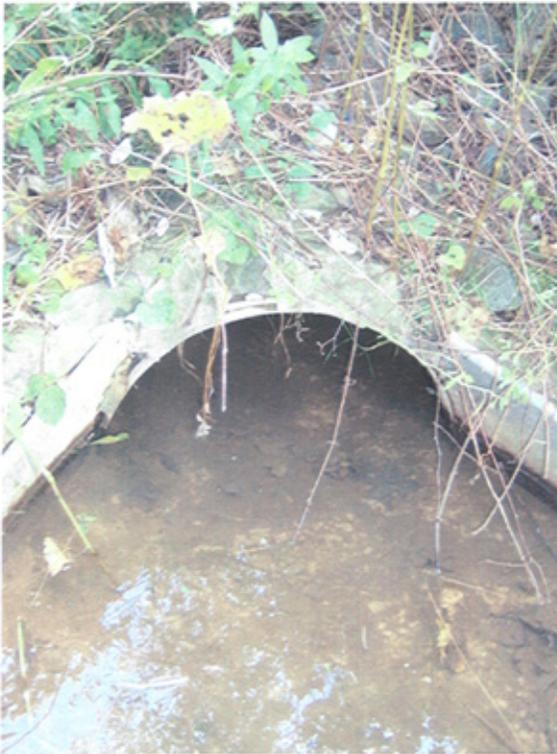
Culvert 2

24" CMP with bottom 8' sediment covered

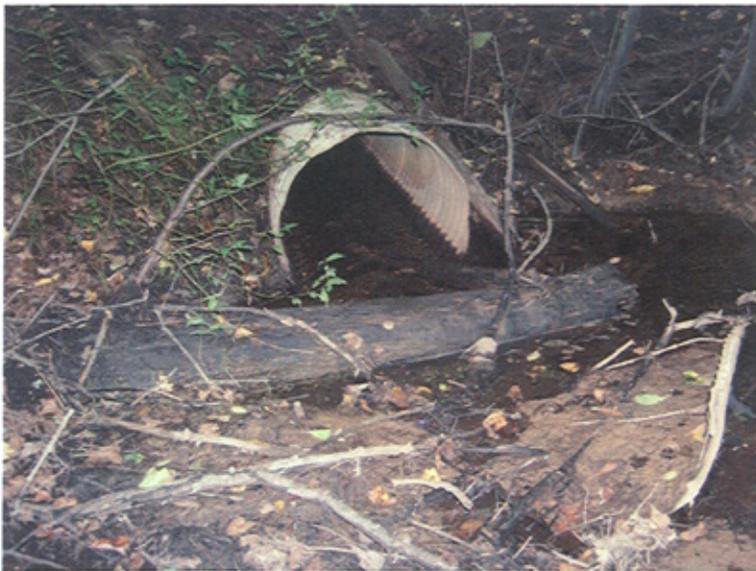
Culvert 3

24" CMP

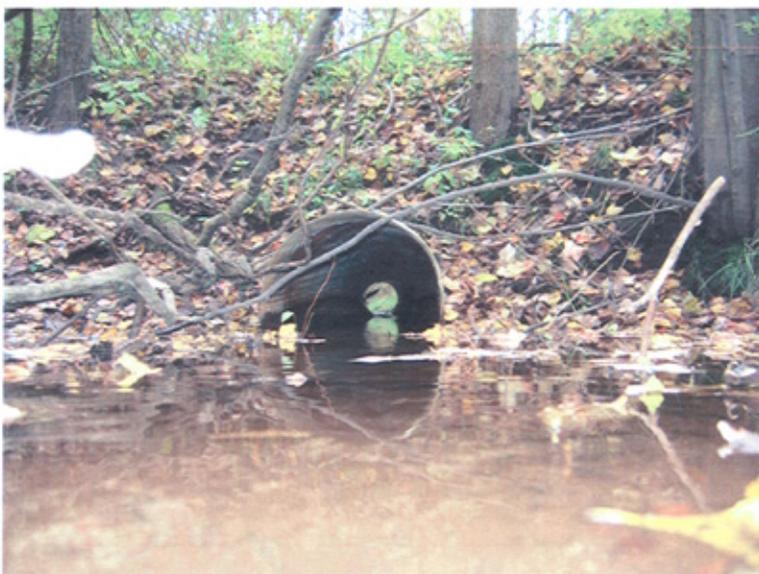
Culvert 4

18" CMP

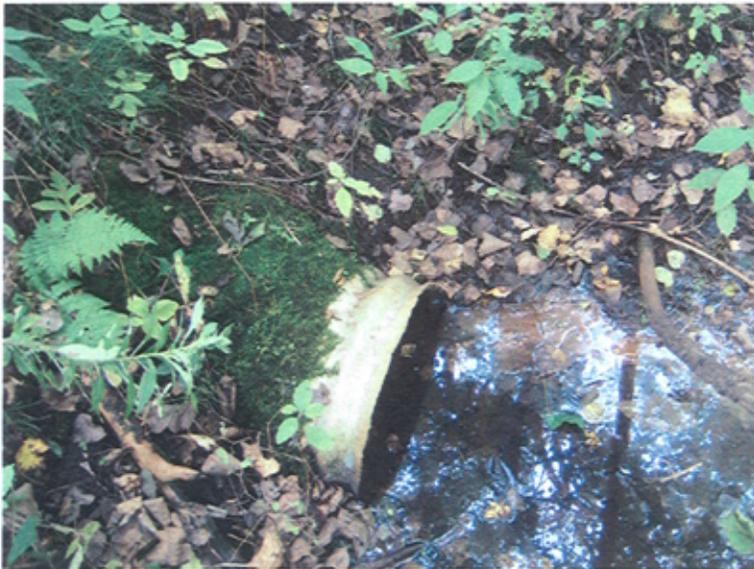
Culvert 5

24" CMP

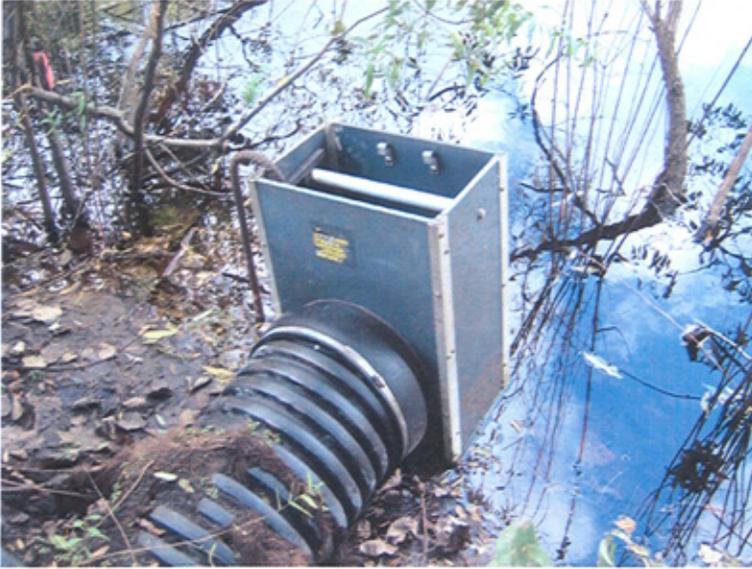
Culvert 7

10x16 rectangular riser (10" above outlet top) discharging through 12" plastic corrugated pipe

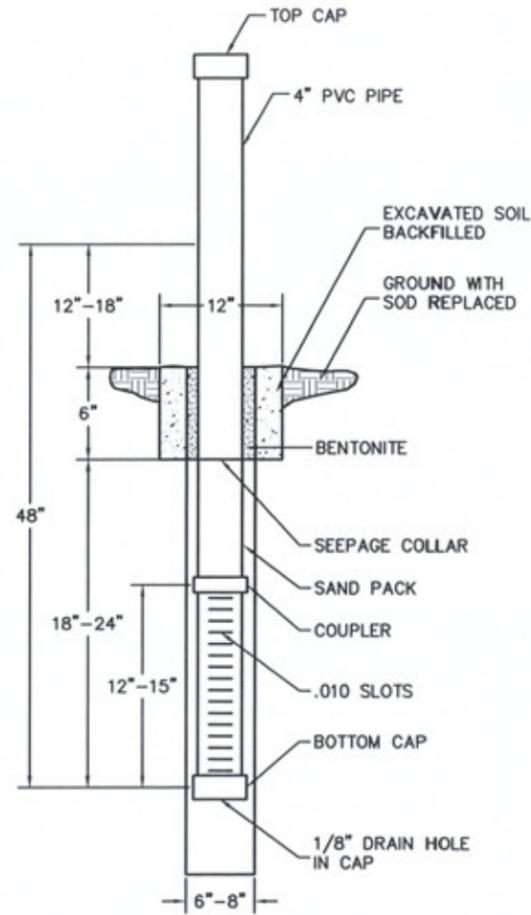
PIEZOMETER DETAIL

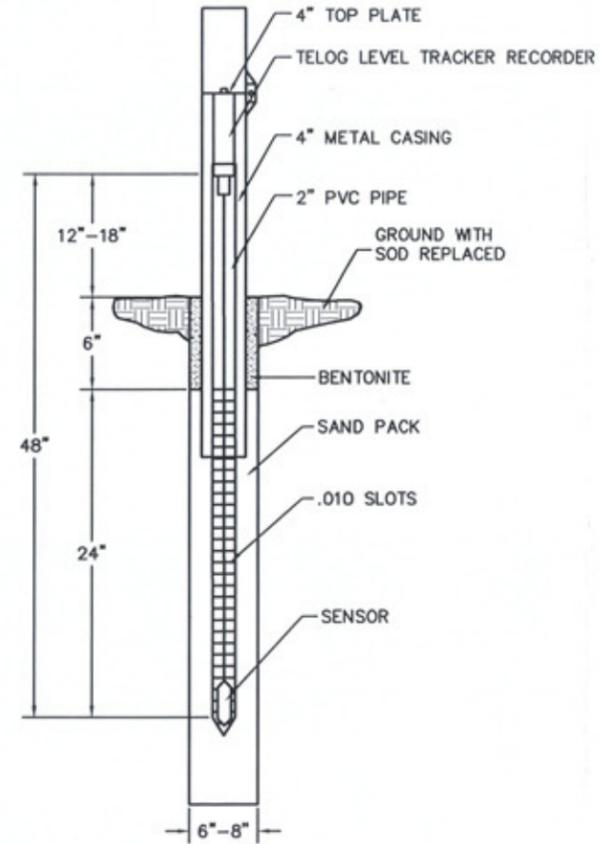
PIEZOMETER WITH TELOG DETAIL

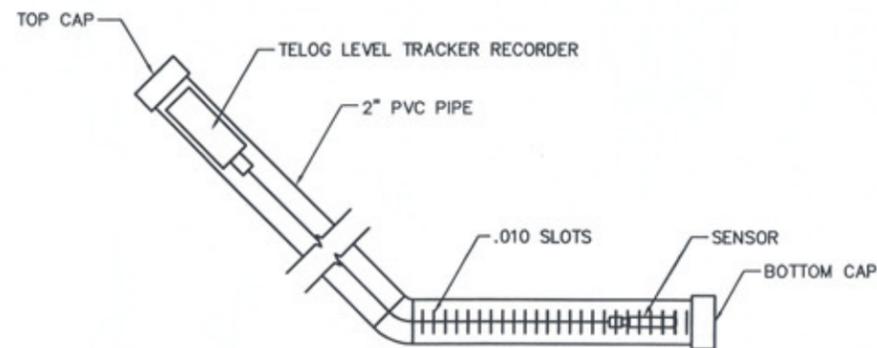
TELOG HORIZONTAL DEPLOYMENT DETAIL

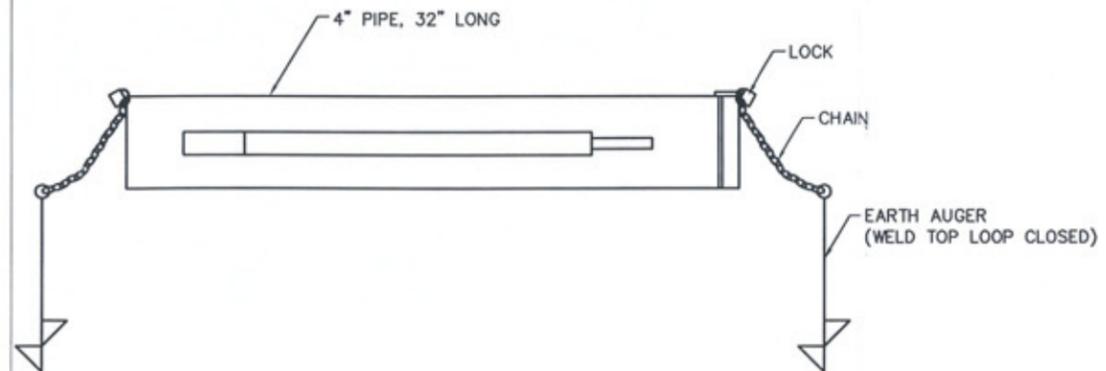
HYDROLAB DEPLOYMENT DETAIL
